Manhole Inspection Summary

Manhole # S29I__007MH

Insp Date: **9/8/08 9:48 AM**

Location Address: **725 - 700 Penn St**

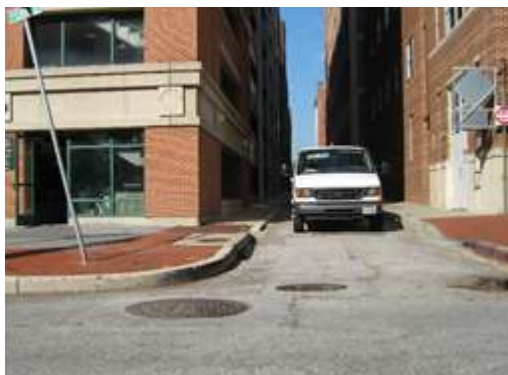
Location View

Intersection of Peen and Lemmon

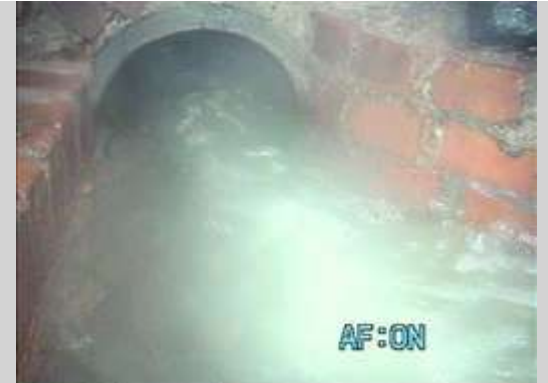
12 O'Clock Outflow

10 in. Circular Gravity Sewer
Pipe Out @ 12 O'Clock

Pipe Height: **10.8** (in.) Rod and Bar (Angled)
Pipe Material: **Clay** ☐ Pipe Lined
Invert Depth: **10.68** (ft.) Flow Characteristics: **Turbulent**
Deposits: ☒ None ☐ Mud ☐ Sludge ☐ Debris ☐ Grease
Silt Depth: **0** (in.) Deposits Extent:
Infiltration: **None** Pipe Seal Cond: **Sound**

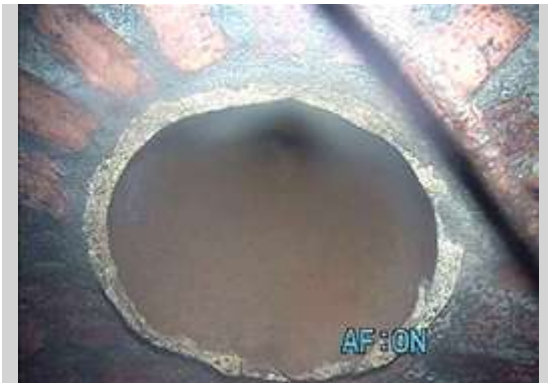
3 O'Clock Inflow

10 in. Circular Gravity Sewer
Pipe In @ 3 O'Clock

Drop In @ 3 O'Clock

Pipe Height: **10.8** (in.) Rod and Bar (Angled)
Pipe Material: **Clay** ☐ Pipe Lined
Invert Depth: **8.58** (ft.) Flow Characteristics: **Turbulent**
Deposits: ☒ None ☐ Mud ☐ Sludge ☐ Debris ☐ Grease
Silt Depth: **0** (in.) Deposits Extent:
Infiltration: **None** Pipe Seal Cond: **Sound**

Drop: **Inside** Rod and Bar
Angled: **Yes** Reading: **9.38** (ft.)
Inv Depth: **10.38** (ft.)
Drop Condition: **Open**

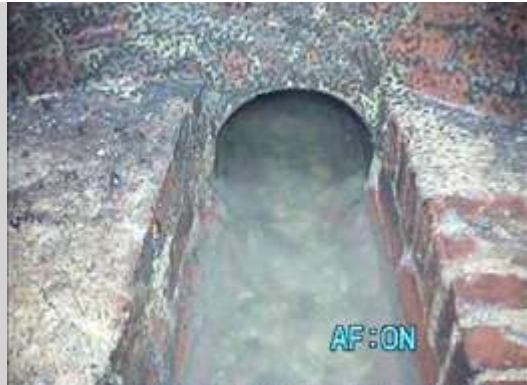
6 O'Clock Inflow

10 in. Circular Gravity Sewer
Pipe In @ 6 O'Clock

Pipe Height: **10.8** (in.) Rod and Bar (Angled)
Pipe Material: **Clay** ☐ Pipe Lined
Invert Depth: **10.63** (ft.) Flow Characteristics: **Turbulent**
Deposits: ☒ None ☐ Mud ☐ Sludge ☐ Debris ☐ Grease
Silt Depth: **0** (in.) Deposits Extent:
Infiltration: **None** Pipe Seal Cond: **Sound**
